# VEHICLE INSPECTION REPORT

**NA25VFU**

## Mercedes-Benz Sprinter 315 CDI

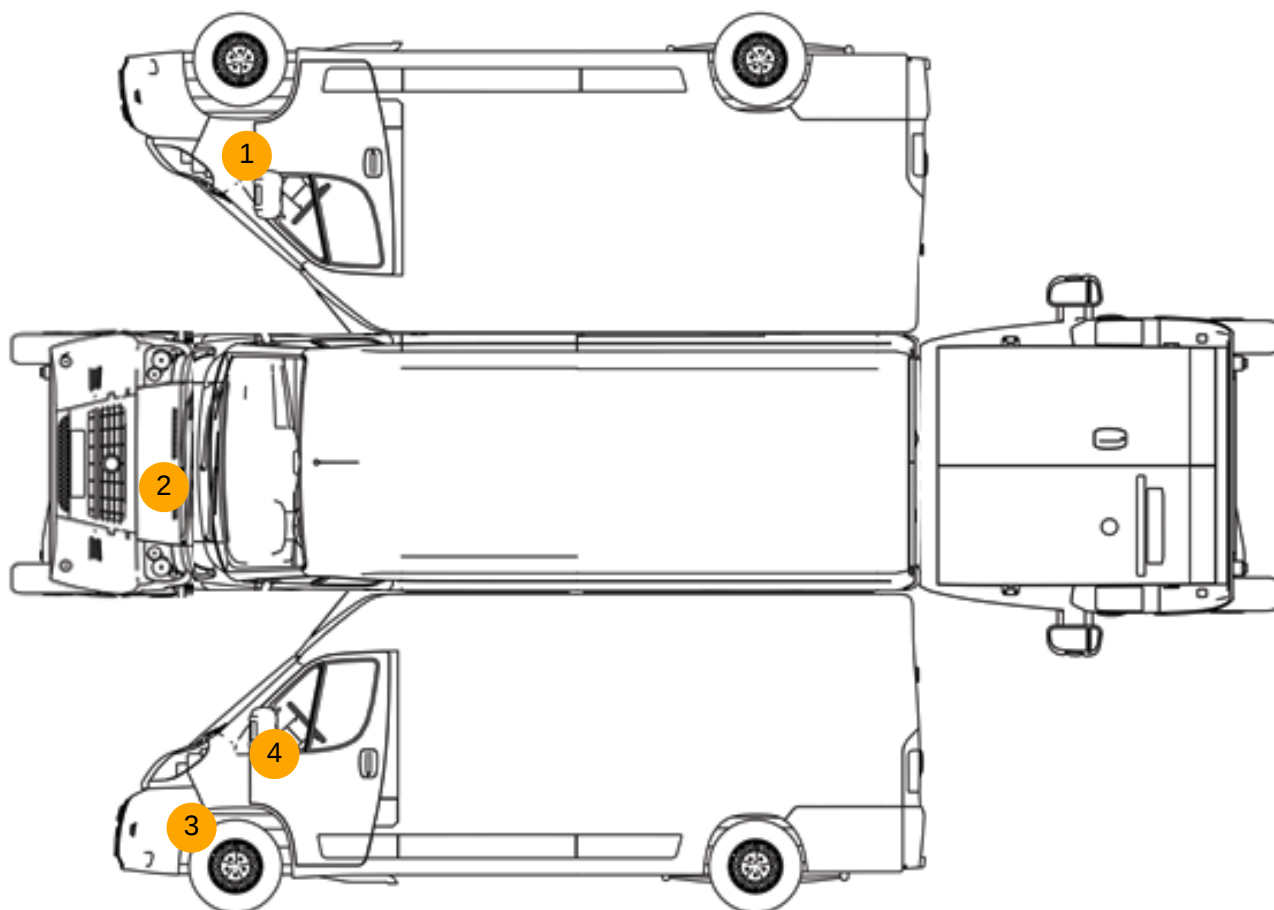
## Condition Check

1: Wing osf  
Scratched  
Over 25mm Thru Paint

2: Bonnet  
Chipped  
Multiple Chips

3: Bumper Front  
Cracked  
Over 25mm

4: Door Mirror Assy nsf  
Broken  
Replace
