## VEHICLE INSPECTION REPORT

**OE21KYC**

### Mercedes-Benz Sprinter 315cdi L3 Diesel Rwd 3.5t Progressive Dropside

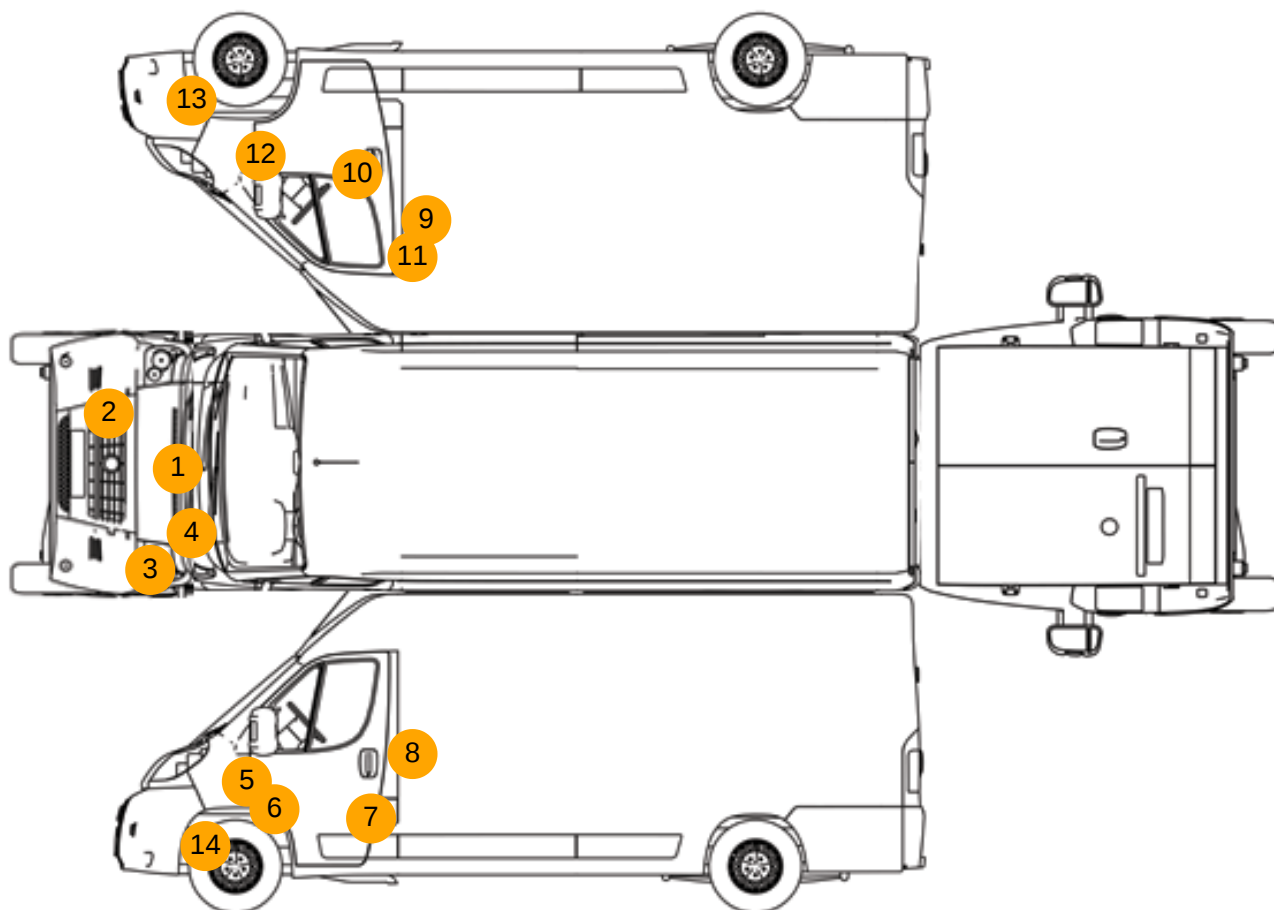
## Condition Check

2: Front TowEye Cvr  
Missing  
Replace

3: Bumper Front Moulding  
Broken  
Replace

6: Wing nsf  
Dented  
With Paint Damage

16: Fascia Trim  
 Damaged  
 Replace

17: In Car Entertainment  
 Broken  
 Replace
