## VEHICLE INSPECTION REPORT

**SL62XEF**

### Volkswagen Crafter CR35 2.0 TDI 109PS

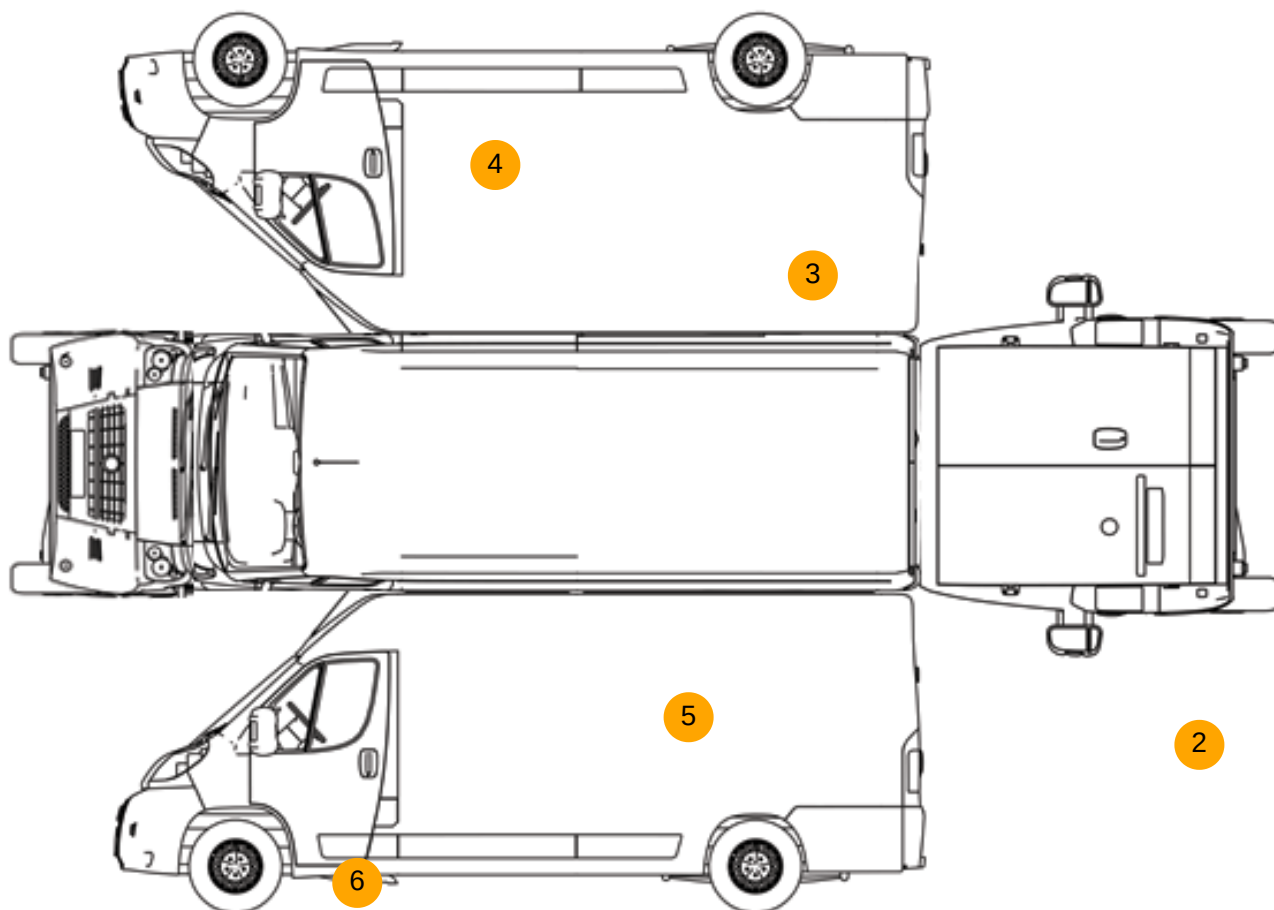
## Condition Check

2: Panel Front  
Rusted  
Over 5mm

3: Panel Rear  
Rusted  
Over 5mm

5: Panel Rear  
Rusted  
Over 5mm

6: Panel Front  
Rusted  
Over 5mm
