# VEHICLE INSPECTION REPORT

**PF66KKR**

## Daf CF 440

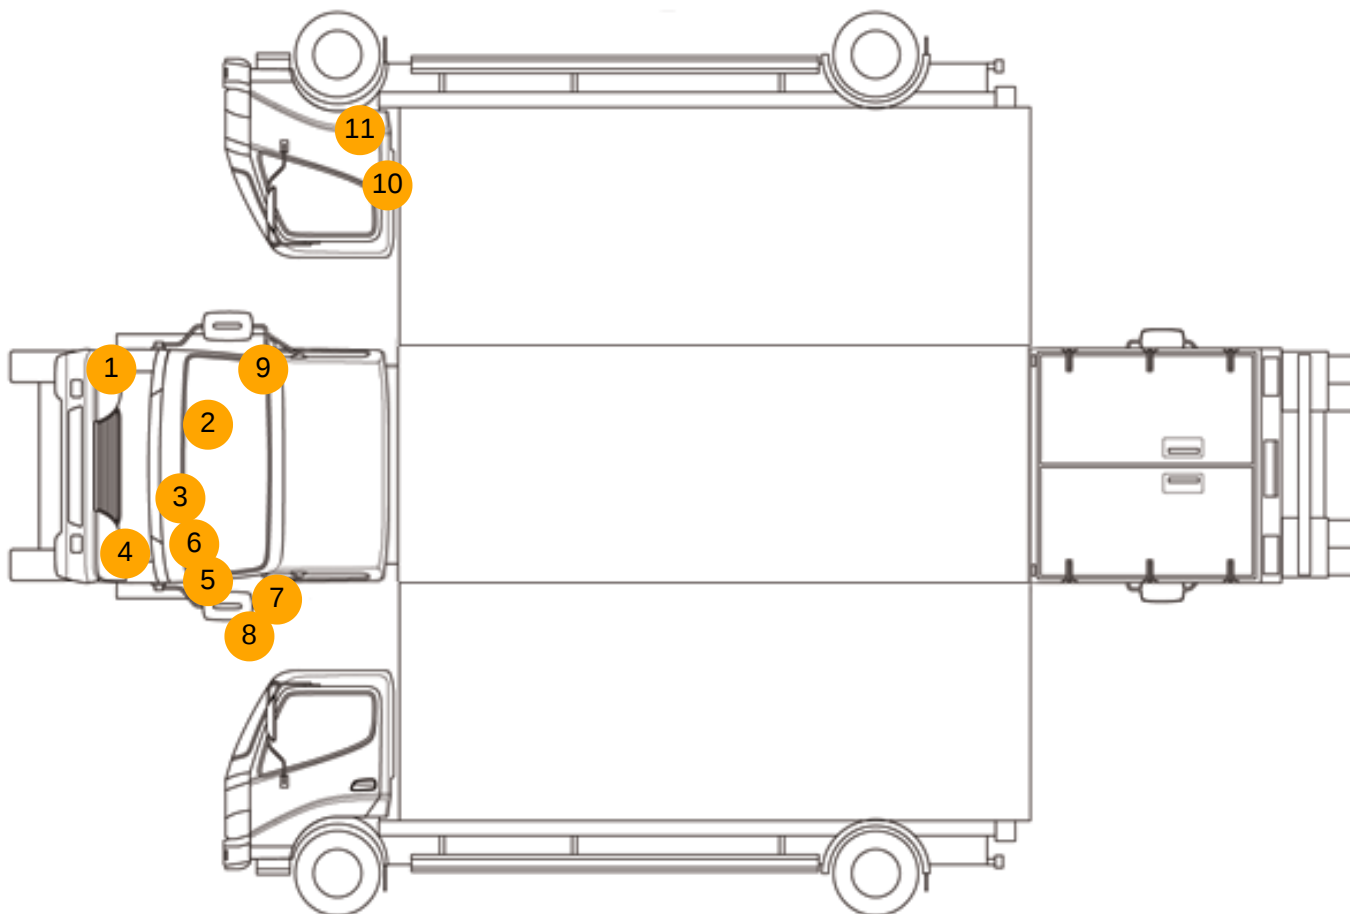
## Condition Check

8: Door Mirror Assy nsf  
Broken  
Replace

12: Centre Console Front  
Broken  
Replace

13: Switches And Controls  
Broken  
Replace
