VEHICLE INSPECTION REPORT

PN19DLK

Fiat Ducato 35 2.3 MULTIJET 130PS

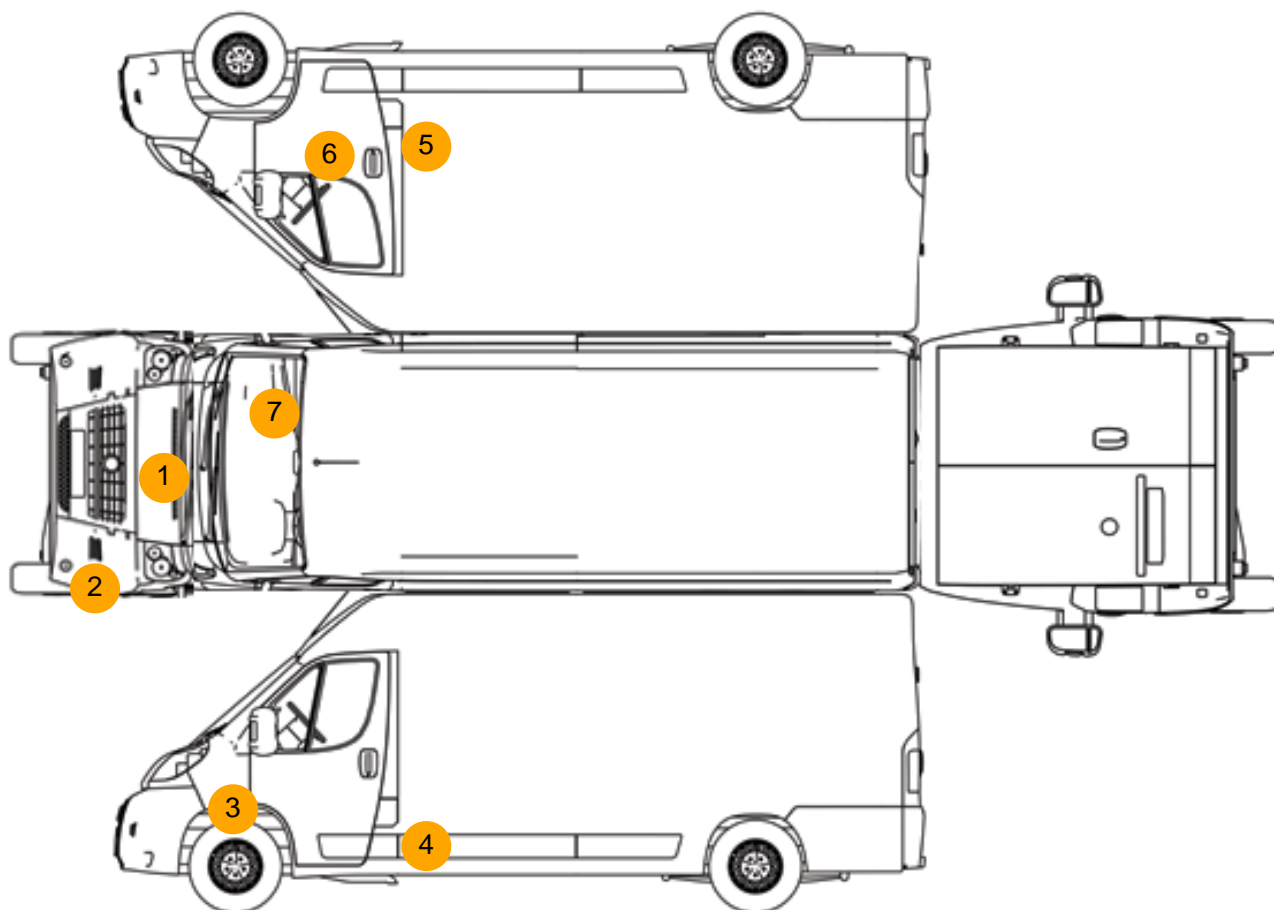
Condition Check

2: Bumper Front
Cracked
Over 25mm

3: Wing nsf
Dented
With Paint Damage

6: Door osf
Dented
With Paint Damage

7: Screen Front
Cracked
Replace
