VEHICLE INSPECTION REPORT

YF71GVR

Maxus Deliver 3

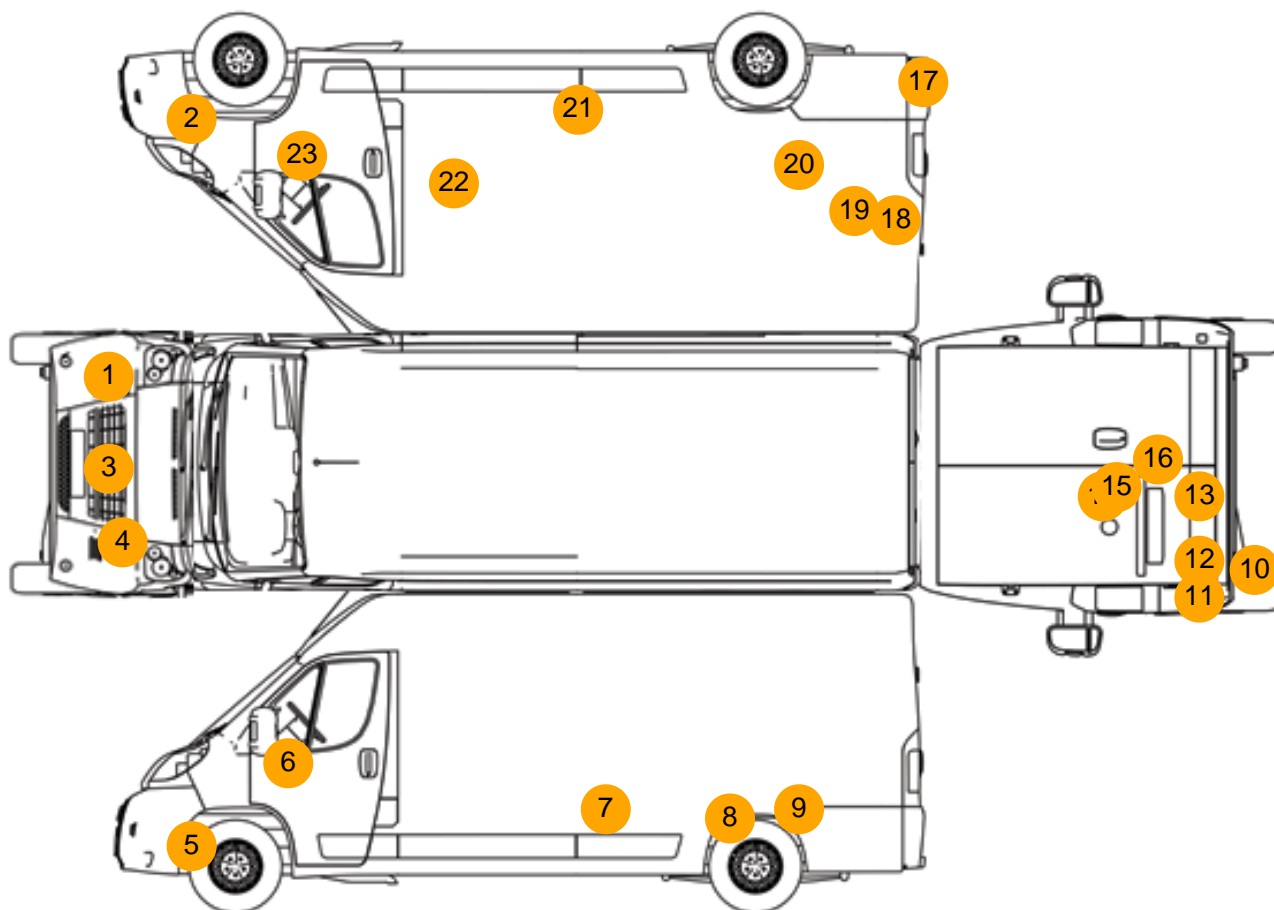
Condition Check

WARNING LIGHT ON DASH SIDE LOAD DOOR, E/MIRRORS

Carpet Condition	OK	Upholstery Condition	OK
Seat Condition	Poor	Odour	No
EML light illuminated	OK	DPF light illuminated	OK
ABS light illuminated	Fault
