VEHICLE INSPECTION REPORT

SJ15TWK

Vauxhall Vivaro 2900 1.6CDTI 115PS

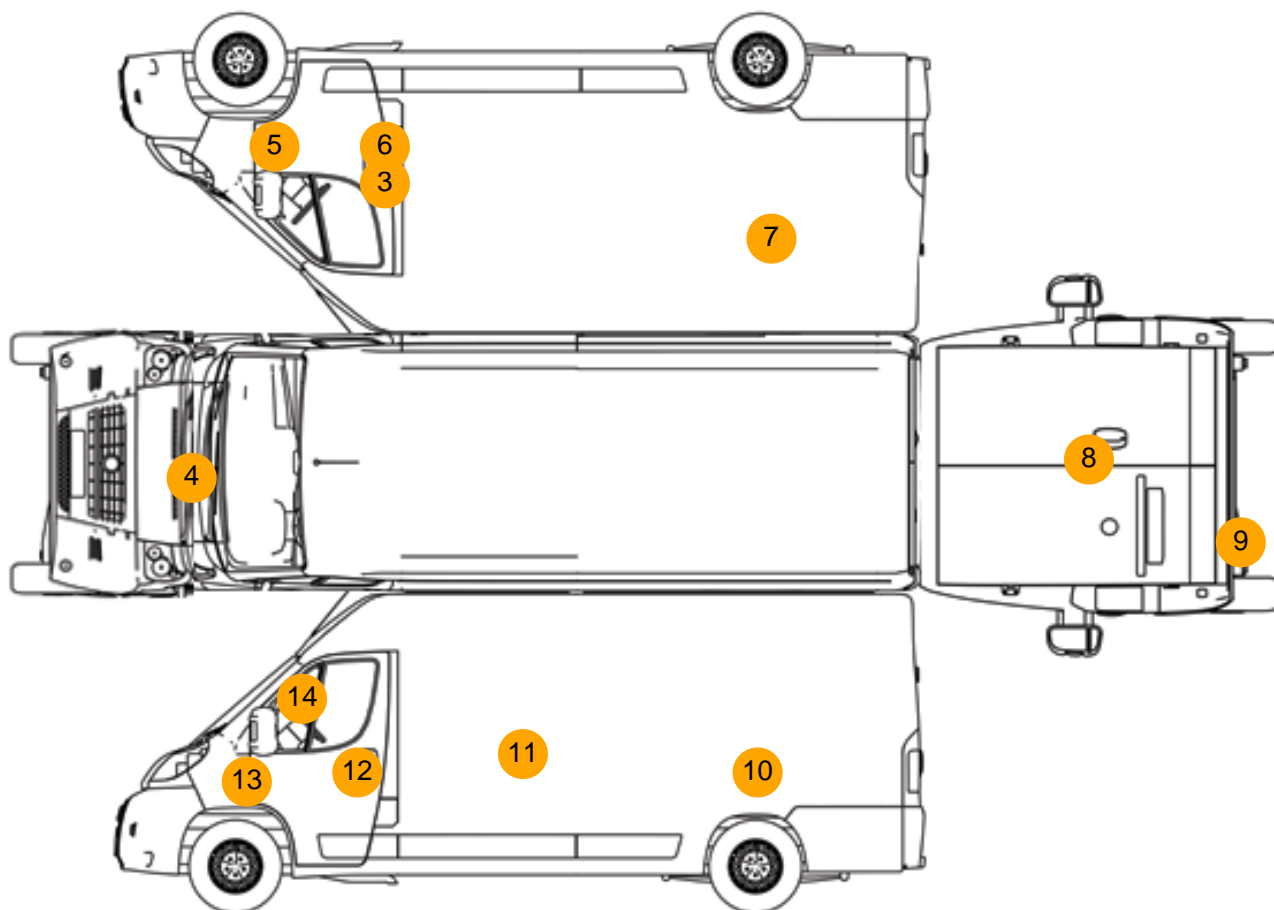
Condition Check

Carpet Condition		Poor Poor	Upholstery Condition		Average No
Seat Condition			Odour		
Engine Runs	OK		Gearbox 1st and Reverse Test	OK	
Brakes	OK		Clutch Slip Test from Static	OK	
Turbo Boosting	OK		Gearbox Static Gear Selection (engine running)	OK	
Parking Brake	OK		No Excessive Smoking	OK	
EML light illuminated	OK		Oil warning light illuminated	OK	
Airbag light illuminated	OK		DPF light illuminated	OK	
ABS light illuminated	OK		Service indicator light illuminated	OK	
Windows	OK		Radio	OK	
			Steering	OK
