VEHICLE INSPECTION REPORT

ND67CXB

Mercedes-Benz Sprinter 314 Cdi

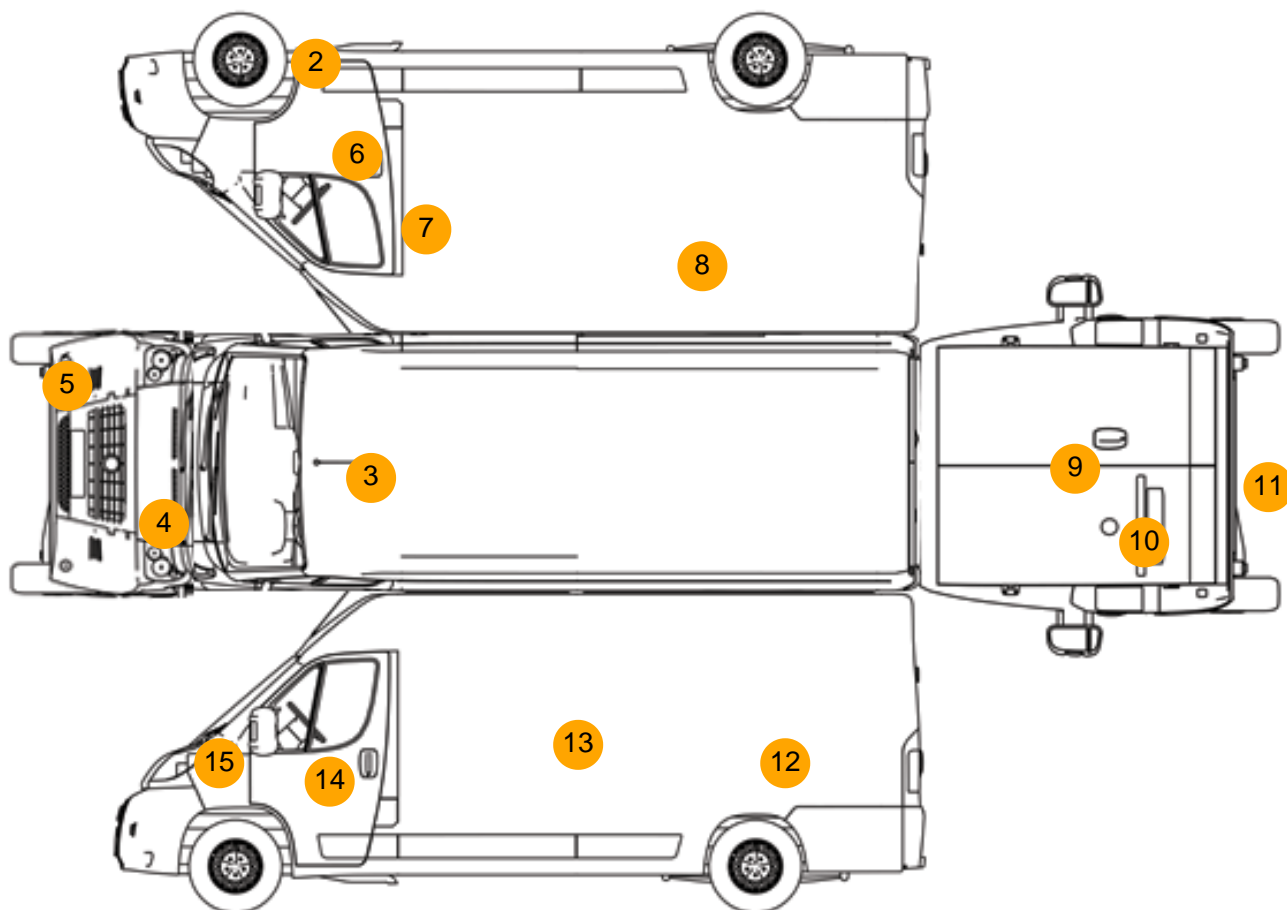
Condition Check

2: Sill os
Rusted
Over 5mm

3: Roof
Rusted
Over 5mm

4: Bonnet
Dented
With Paint Damage

7: B Post os
Rusted
Over 5mm

8: Qtr Panel osr
Rusted
Over 5mm

9: Badgedecal Rear
Broken
Replace

10: Tailgate
Dented
With Paint Damage

11: Bumper Rear Moulding
Broken
Replace

12: Qtr Panel nsr
Rusted
Over 5mm

15: Wing nsf
Rusted
Over 5mm
