VEHICLE INSPECTION REPORT

SH71GHX

Fiat Doblo CARGO 16V 1.6 MULTIJET

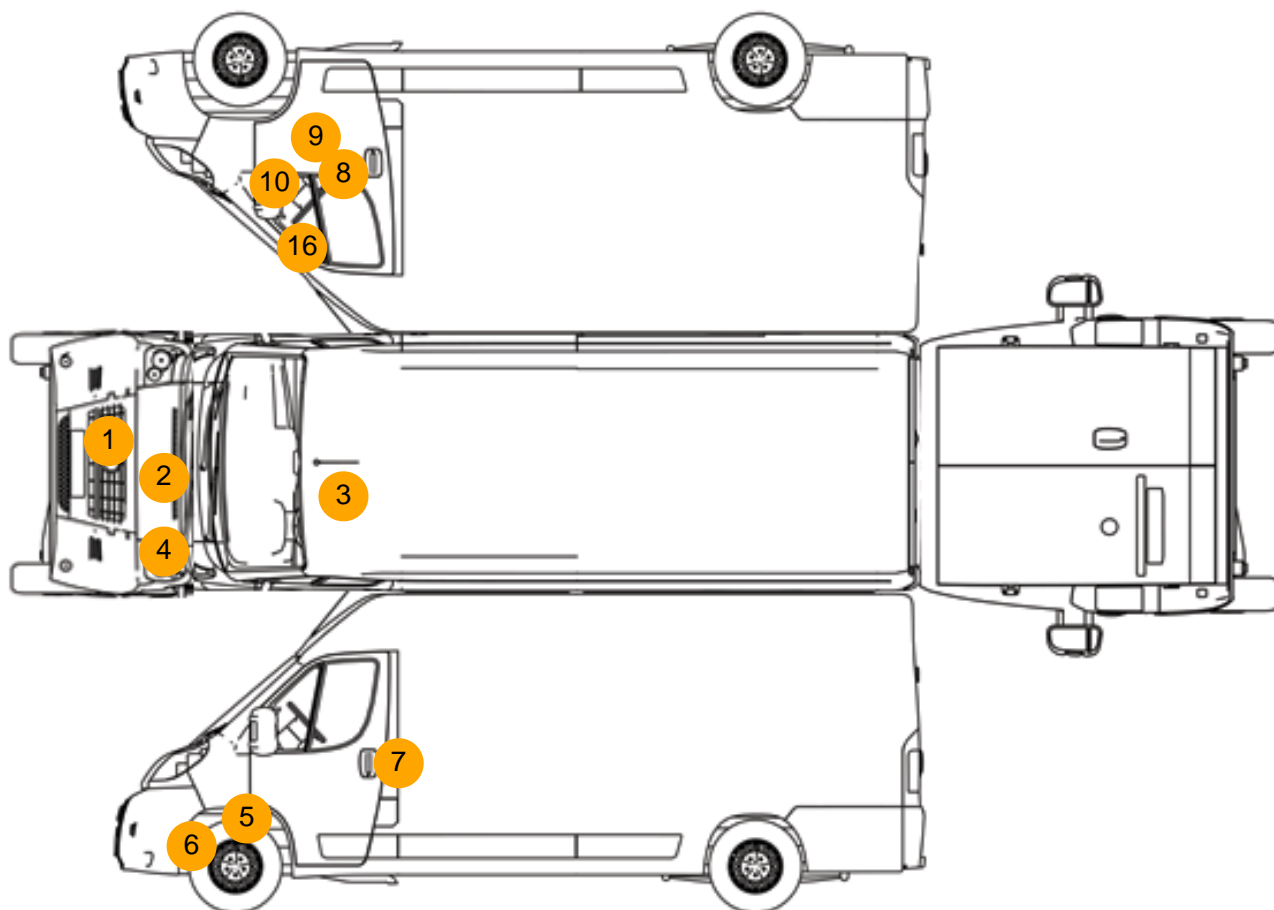
Condition Check

1: Bumper Front Moulding
Missing
Replace

5: Wing nsf
Dented
With Paint Damage

16: Door Mirror Assy osf
Broken
Replace
