# VEHICLE INSPECTION REPORT

**SH71GHB**

## FIAT DOBLO CARGO 16V 1.6 Multijet

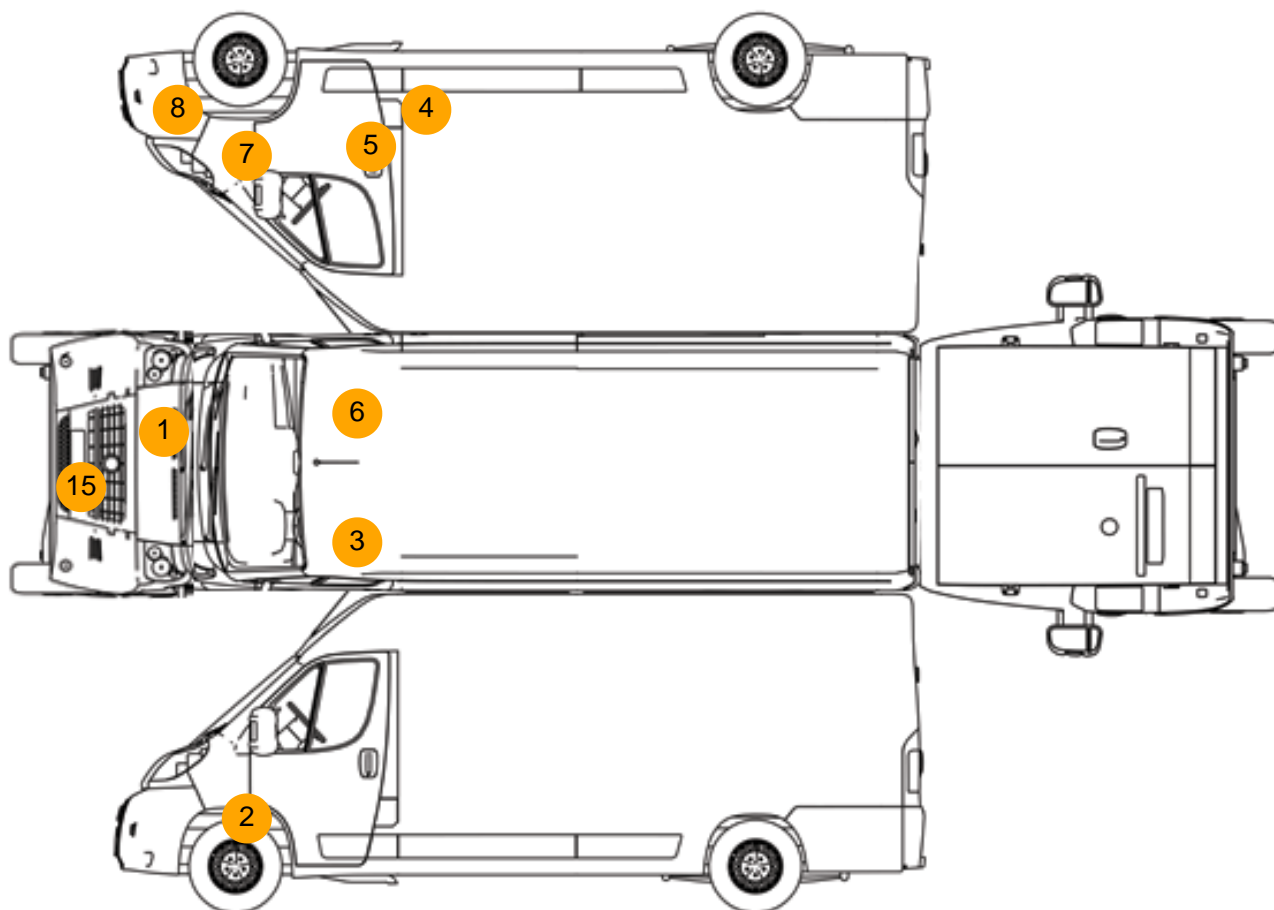
## Condition Check

1: Bonnet  
Dented  
With Paint Damage

2: Wing nsf  
Dented  
With Paint Damage

5: Door osf  
Dented  
With Paint Damage

10: Fascia Panel  
Missing  
Replace

15: Number Plate Front  
Broken  
Replace
