VEHICLE INSPECTION REPORT

CU64FJP

Ford Transit 350 2.2 TDCI 100PS

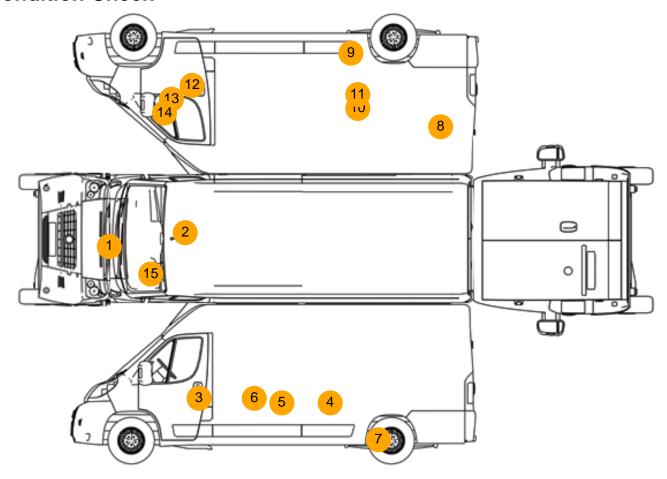
Condition Check

Carpet Condition Seat Condition	OK Poor		Upholstery Condition Odour	Poor No	
Engine Runs		OK	No Excessive Smoking		OK
EML light illuminated		OK	DPF light illuminated		ОК
ABS light illuminated		OK
