VEHICLE INSPECTION REPORT

WJ65YVP

Isuzu D-Max 2.5 TD TURBO

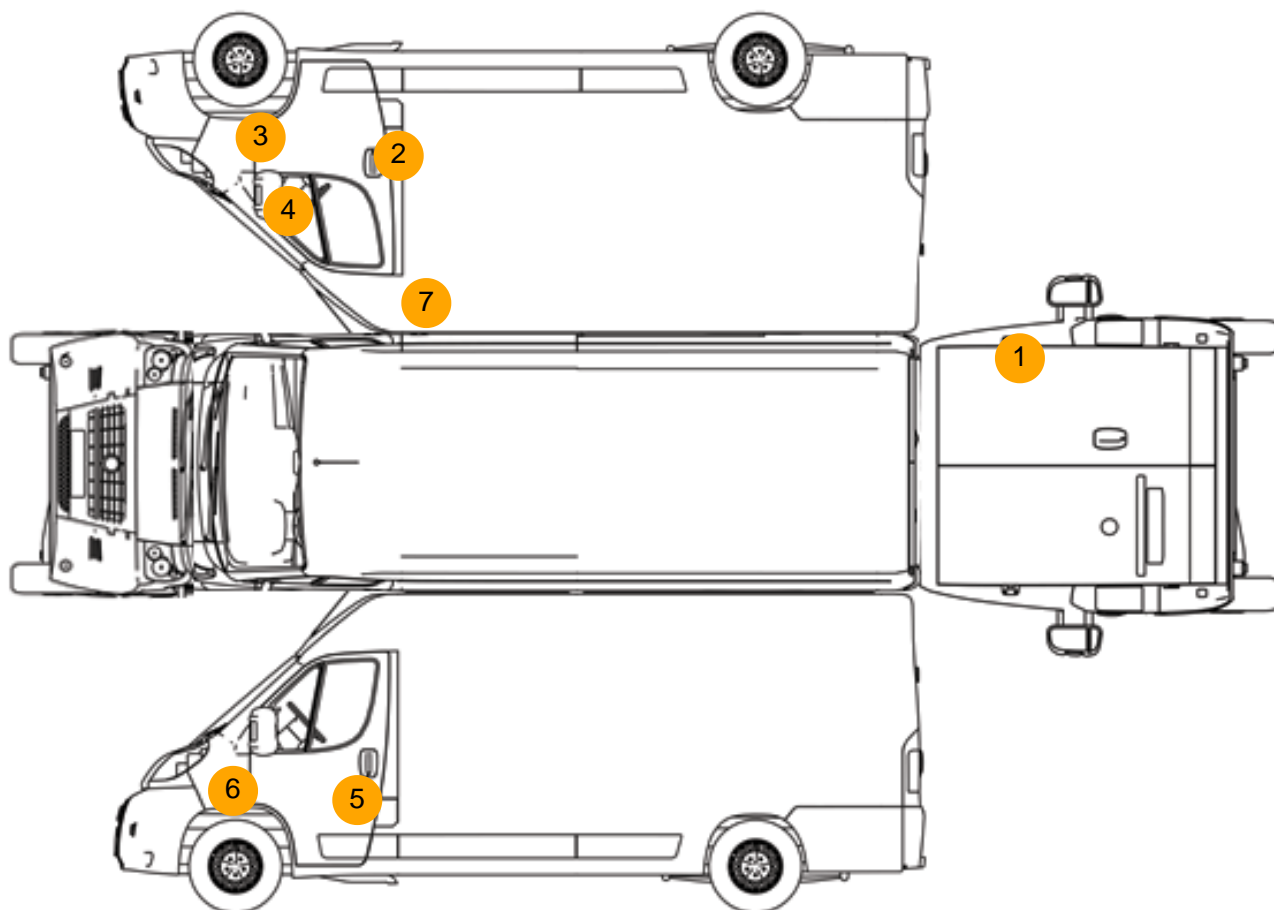
Condition Check

3: Wing osf
Dented
With Paint Damage

4: Door Mirror Assy osf
Broken
Replace

6: Wing nsf
Scratched
Rusted
