VEHICLE INSPECTION REPORT

WD65UCW

Isuzu D-Max 2.5 TD TURBO

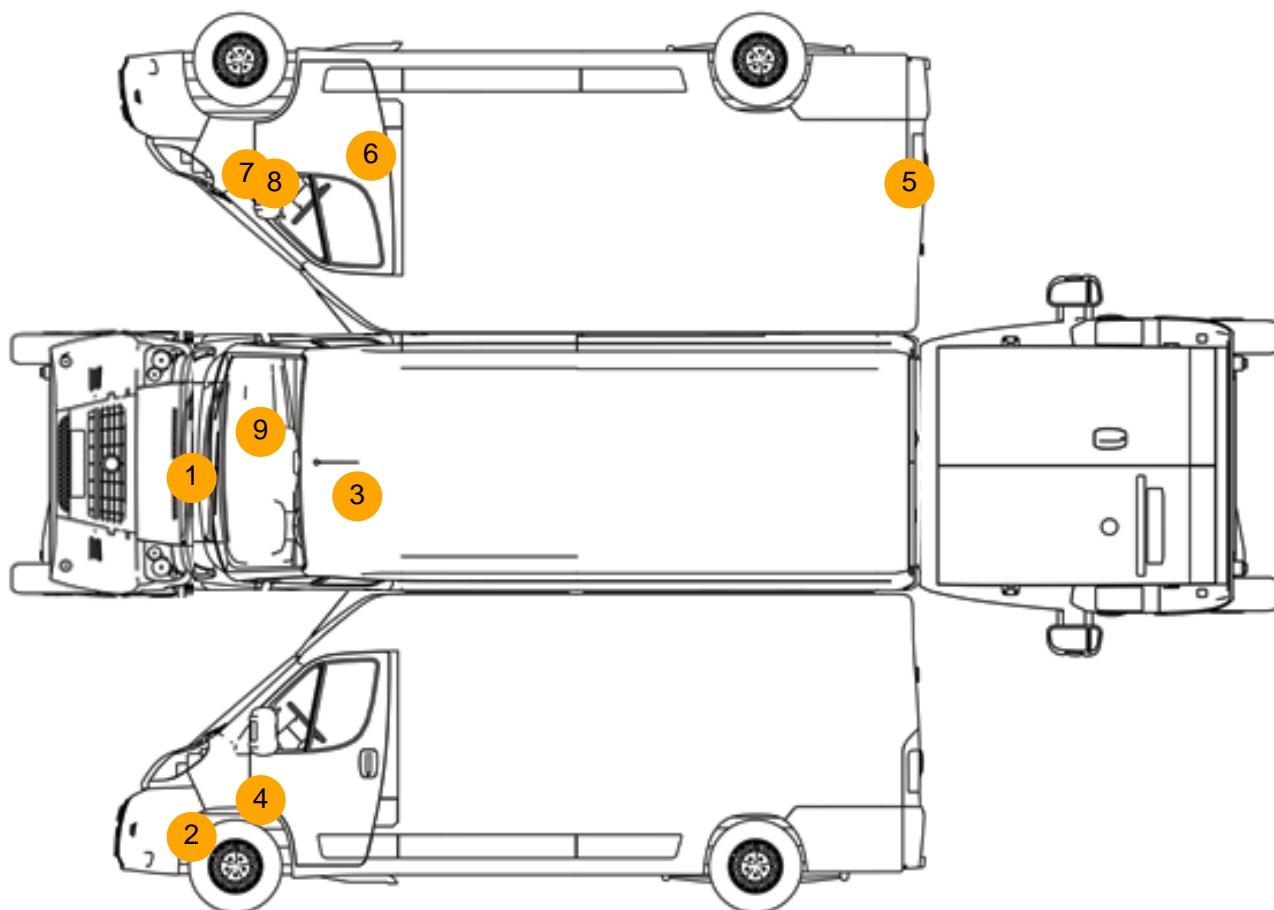
Condition Check

Carpet Condition	OK	Upholstery Condition	OK
Seat Condition	Poor	Odour	No
Engine Runs	OK	No Excessive Smoking	OK
EML light illuminated	OK	DPF light illuminated	Fault
ABS light illuminated	OK
