# VEHICLE INSPECTION REPORT

**CU64FKG**

## Ford Transit 350 2.2 TDCI 100PS

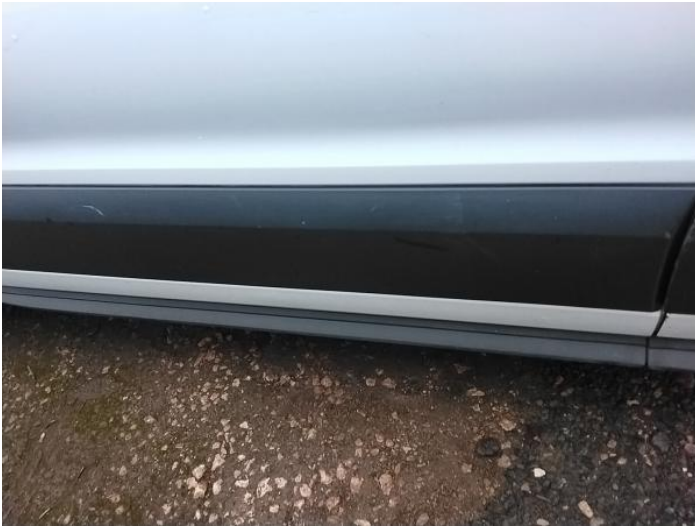
39: Qtr Panel Moulding os  
Scuffed (Unpainted)  
Over 100mm
