## VEHICLE INSPECTION REPORT

**PO70ZFY**

### Mitsubishi L200 DI-D 2.3 Barbarian X 150PS

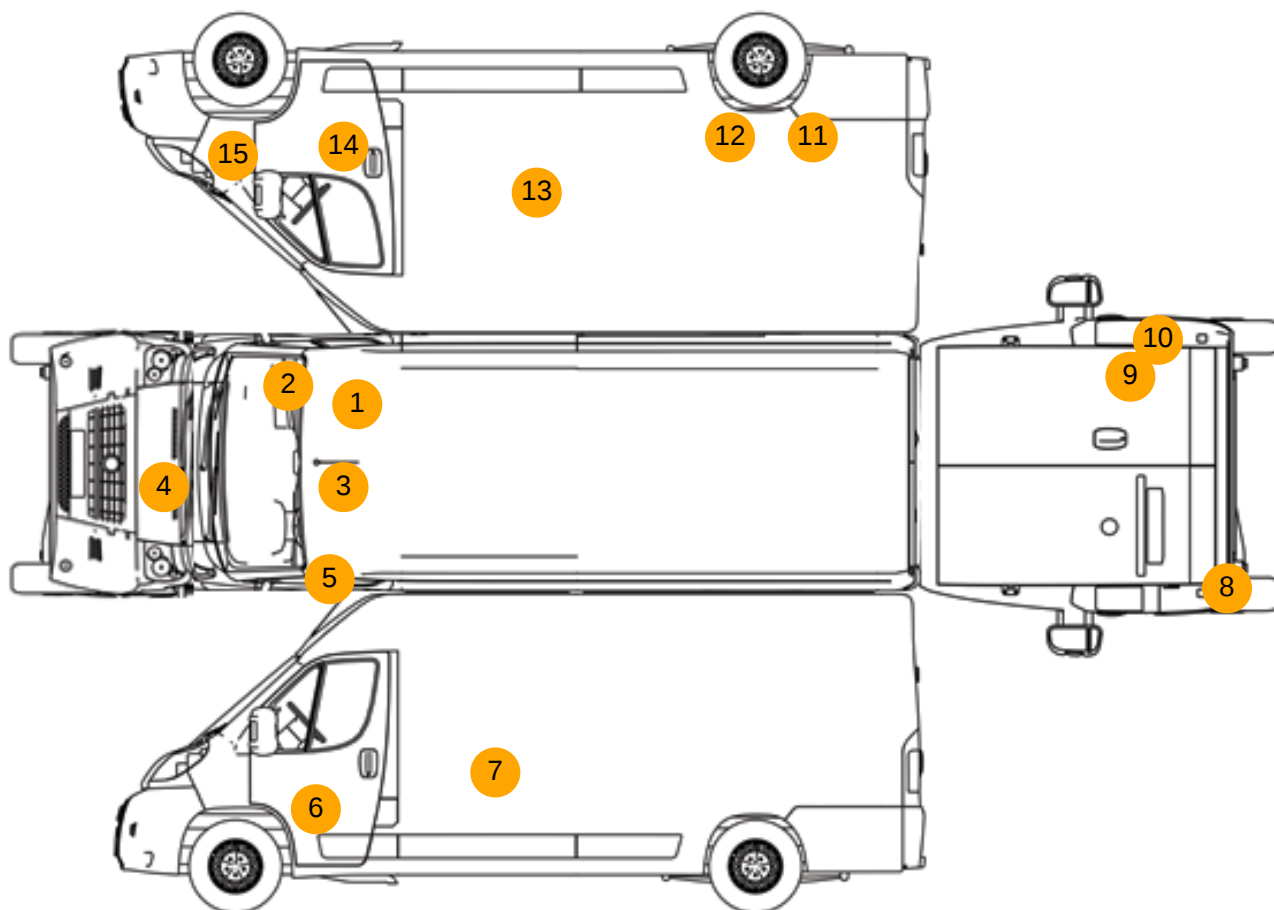
## Condition Check

\*CRACK IN WINDSCREEN, WARNING LIGHT ON DASH\* AD-BLUE, TWIN SIDE LOAD DOOR, E/ MORRORS, HEATED SEATS
