Commercial Vehicle Auctions Ltd.

MF70BMU

CITROEN RELAY 35 2.2 BLUE HDI 140PS  
ENTERPRISE

#### Vehicle Splat

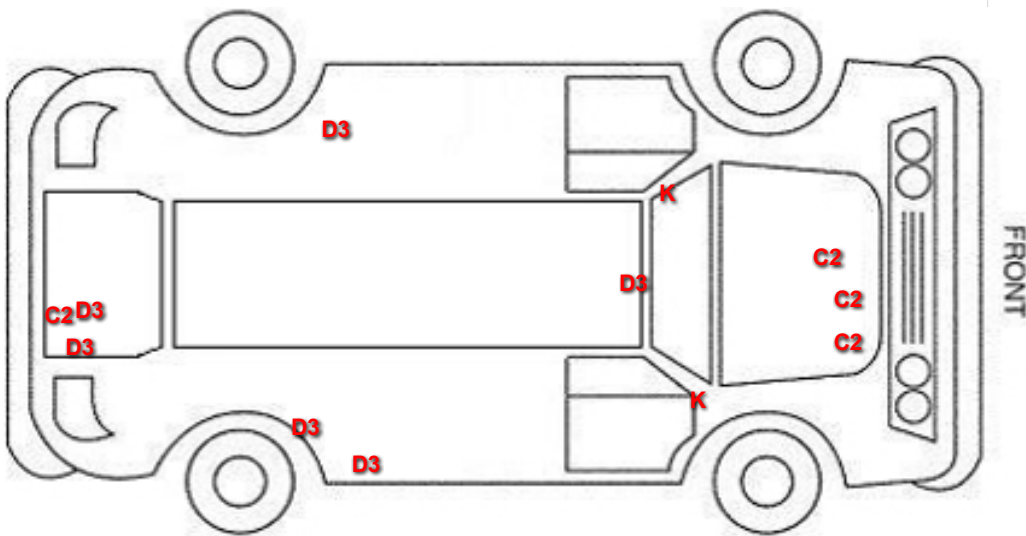
| Component | Condition | Severity | Repair |
|---|---|---|---|
| Bonnet | Chipped | Multiple Chips | Refinish |
| Roof | Dented | Over 30mm | Repair and Refinish |
| Door Mirror Assy nsf | Broken | Replace | Replace |
| Unclassified | Substantial Accident Damage | Report Only | Report Only (Grade) |
| Door osr | Dented | Over 30mm | Repair and Refinish |
| Door nsr | Dented | Over 30mm | Repair and Refinish |
| Door osr | Chipped | Multiple Chips | Refinish |
| Carpets Front | Torn | Over 10mm | Replace |
| Seat Base Cover nsf | Soiled | Heavy | Replace |
| Door Mirror Assy osf | Broken | Replace | Replace |
