VEHICLE INSPECTION REPORT

YH20UET

Mercedes-Benz Sprinter 314 CDI

Inspection

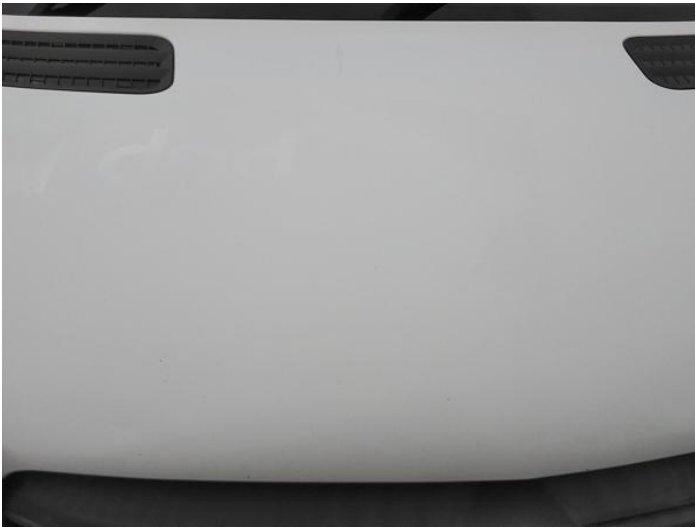
5: Bonnet
Chipped
Multiple Chips

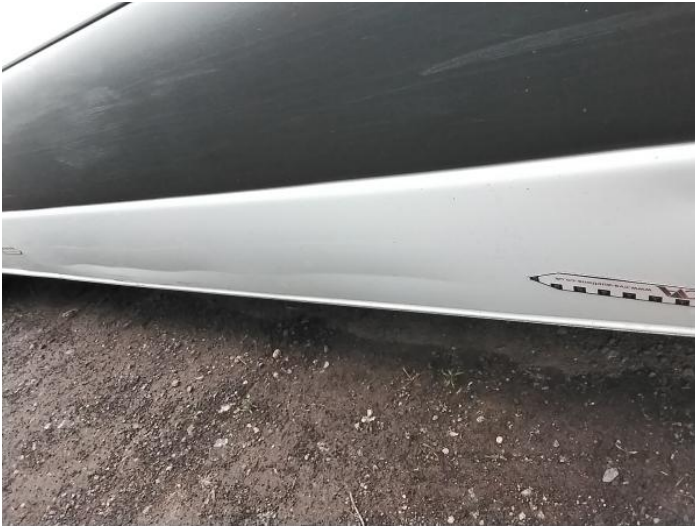
15: Qtr Panel nsr
Dented
Over 30mm

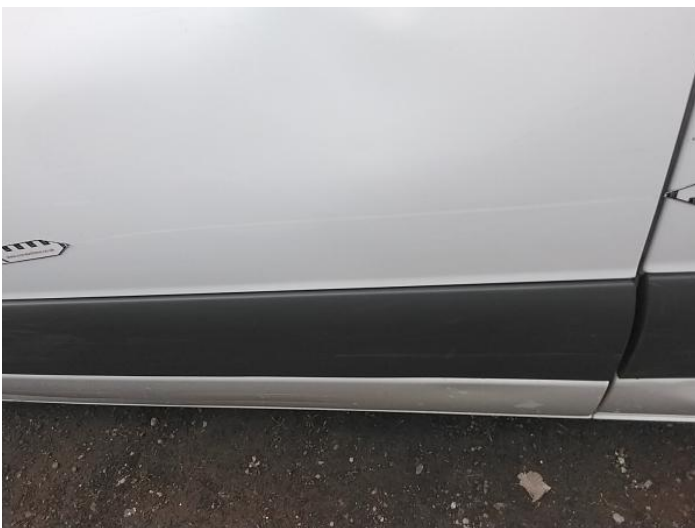
19: Qtr Panel nsr
Scratched
Over 25mm Thru Paint

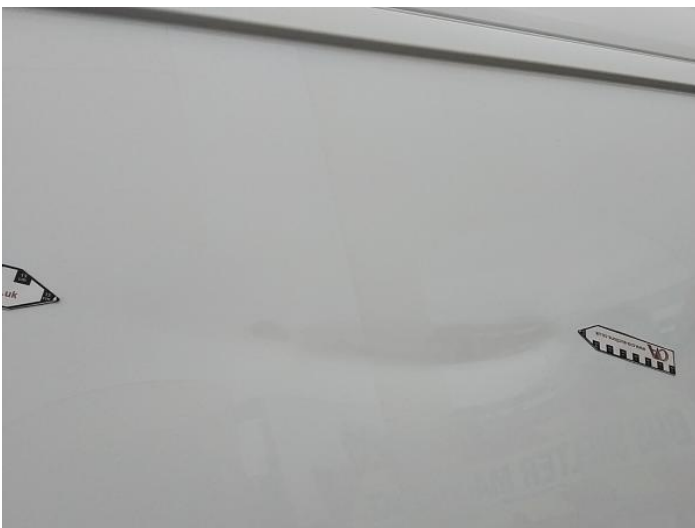
25: Qtr Panel nsr
Dented
Over 30mm

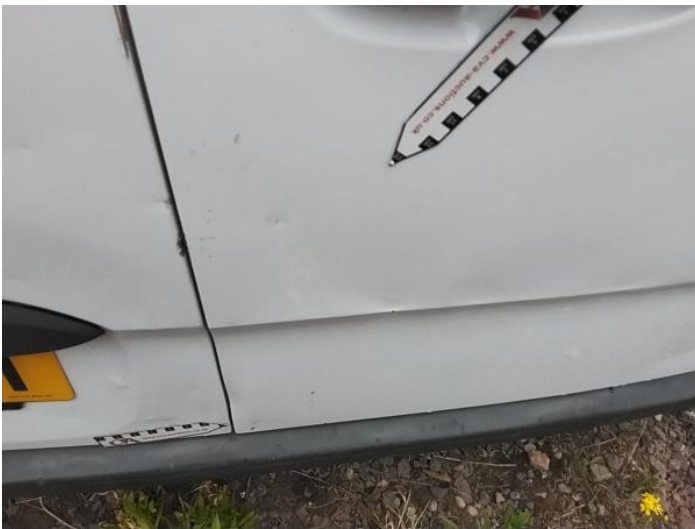
35: Door osr
Dented
Over 30mm

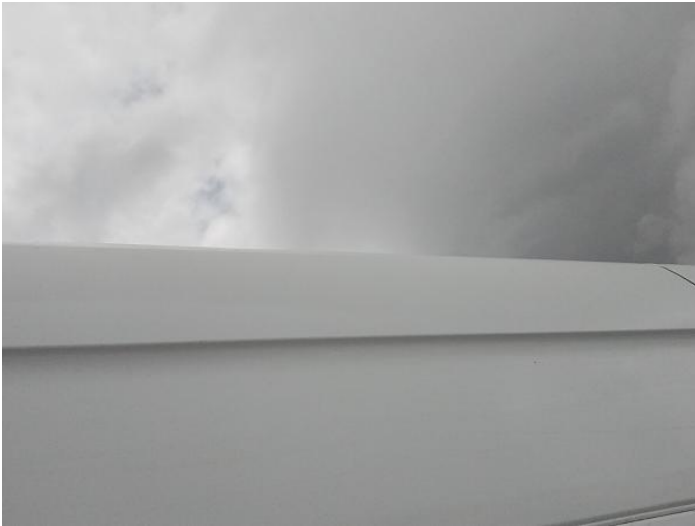
39: Qtr Panel osr
Dented
Over 30mm

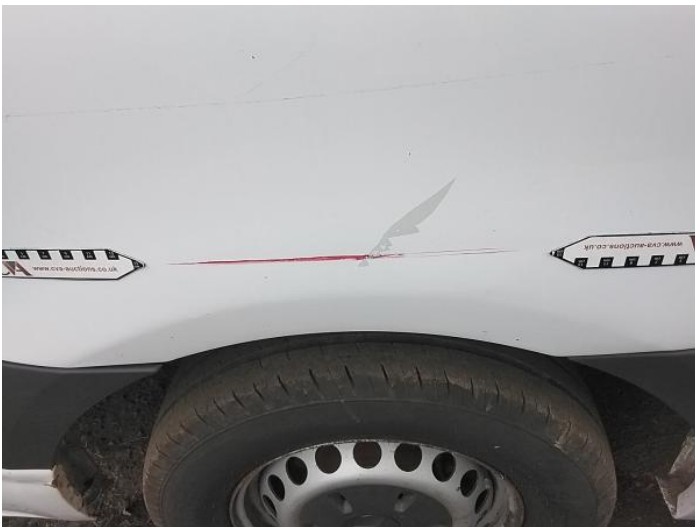
47: Qtr Panel osr
Scratched
Over 25mm Thru Paint

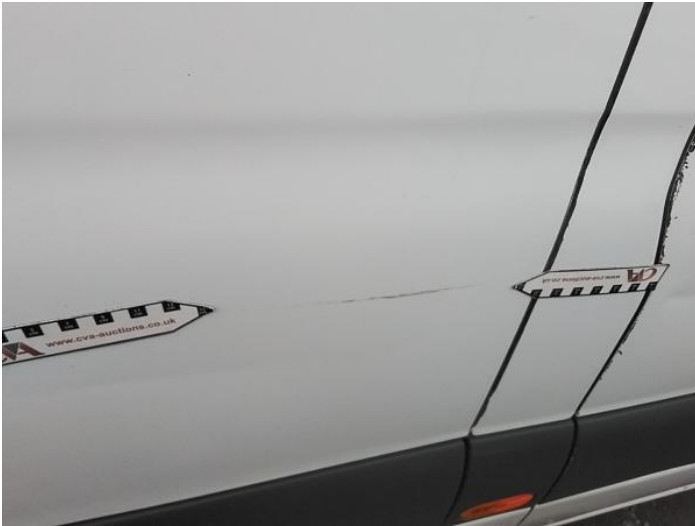
51: Qtr Panel osf
Scratched
Over 25mm Thru Paint

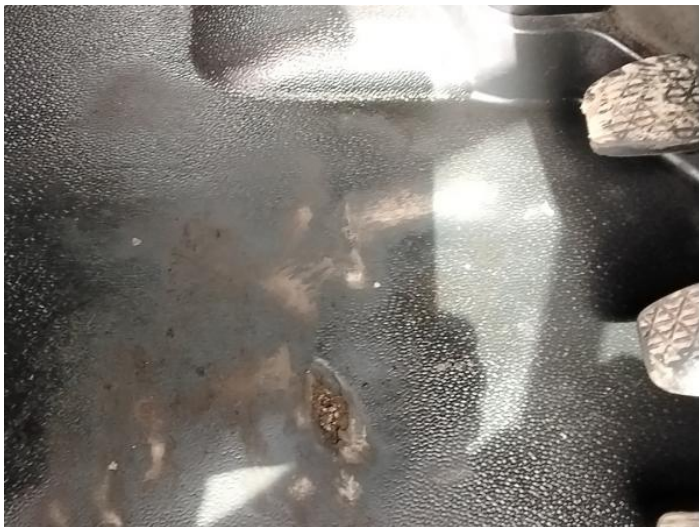
57: Carpets Front
Torn
Over 10mm
