VEHICLE INSPECTION REPORT

HK71PXU

Ford Transit 350 2.0 ECOBLUE 130PS

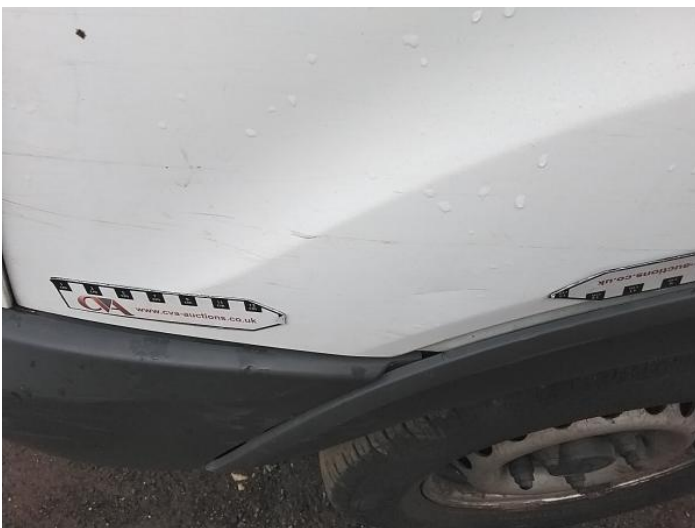
7: Wing nsf
Dented
Over 30mm

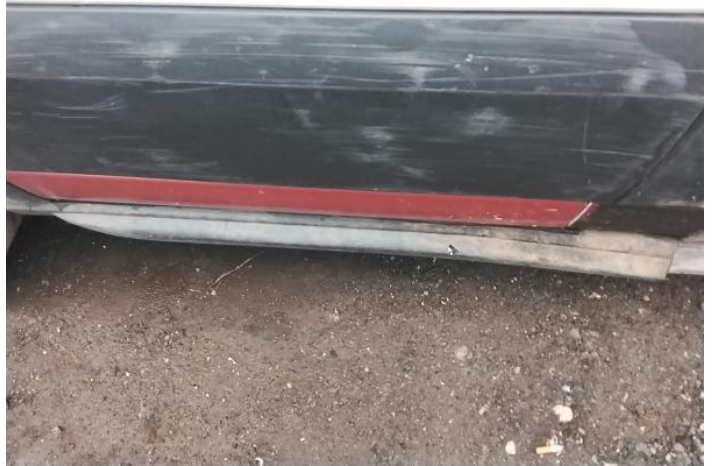
12: Door Moulding nsf
Scuffed (Unpainted)
Over 100mm

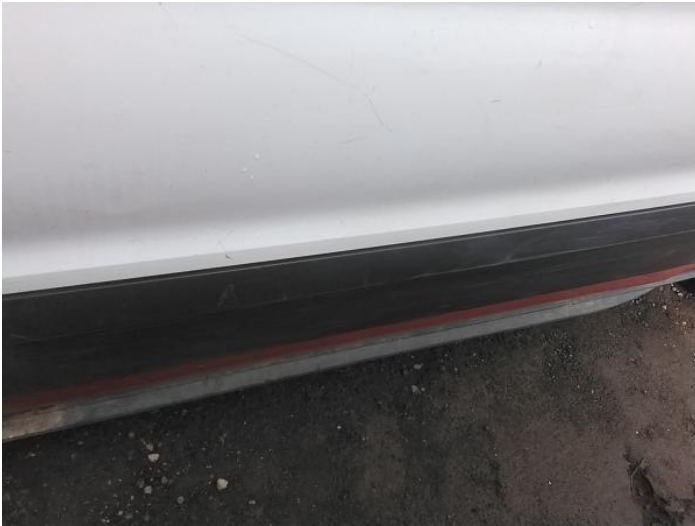
15: Qtr Panel Moulding ns
Scuffed (Unpainted)
Over 100mm

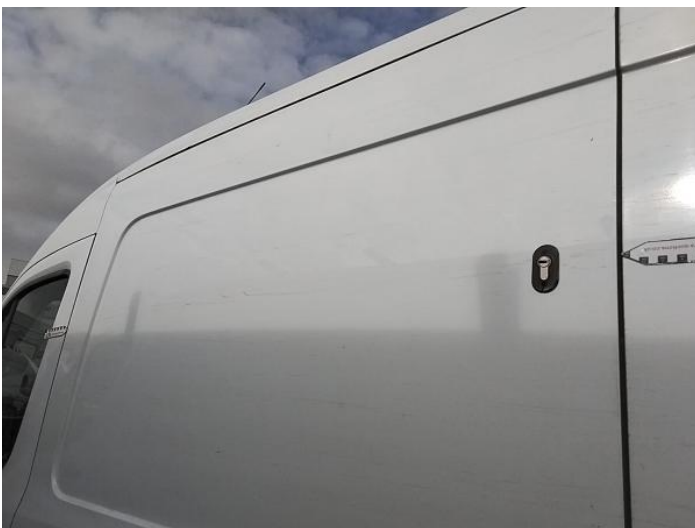
19: Qtr Panel nsr
Scratched
Over 25mm Thru Paint

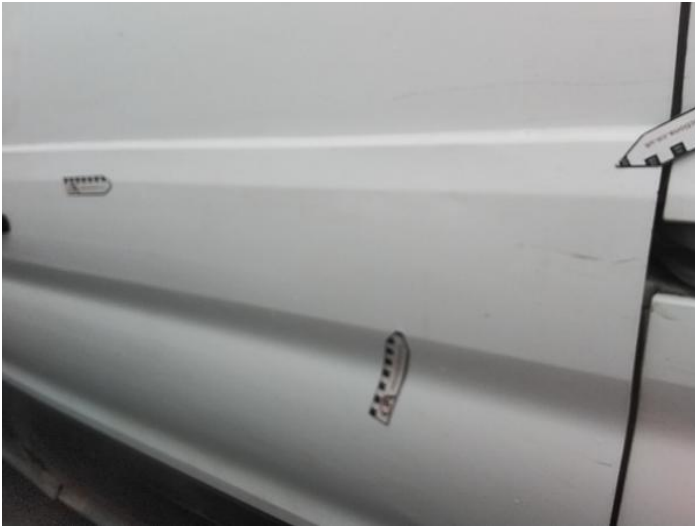
21: Qtr Panel nsr
Dented
Over 30mm

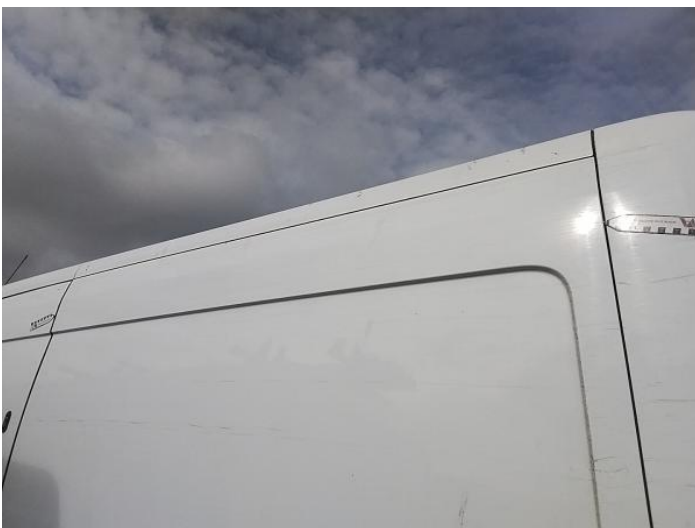
25: Qtr Panel nsr
Scratched
Over 25mm Thru Paint

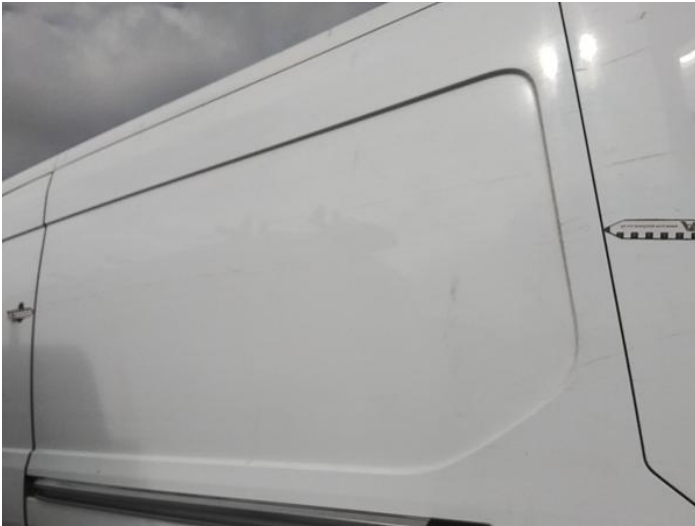
27: Qtr Panel nsr
Scratched
Over 25mm Thru Paint

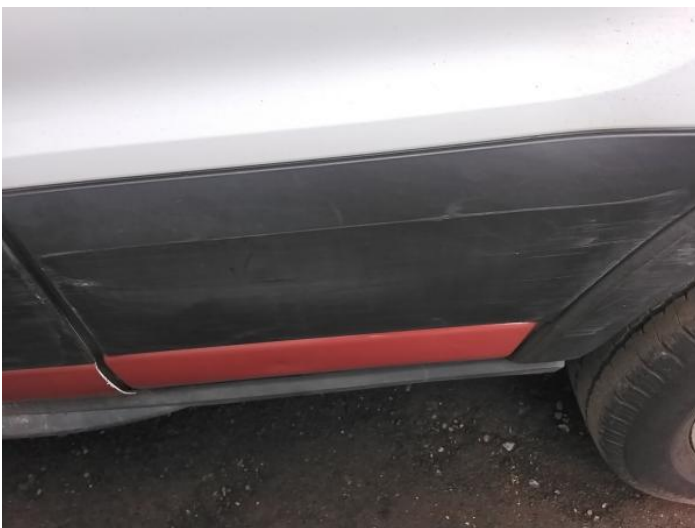
31: Qtr Panel Moulding ns
Scuffed (Unpainted)
Over 100mm

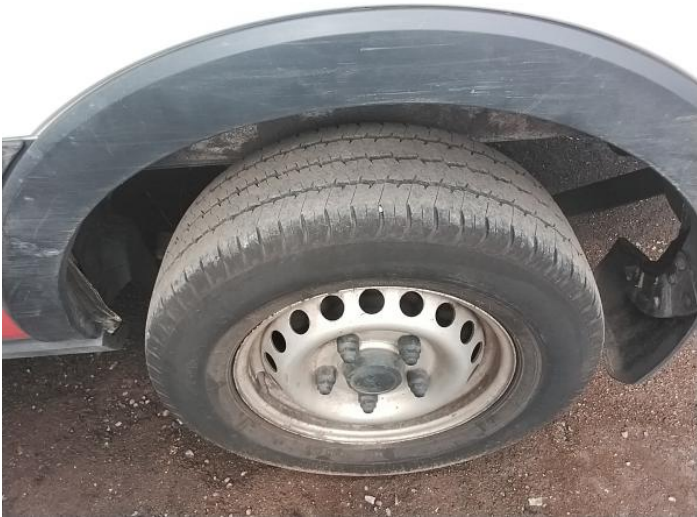
33: Qtr Panel Moulding ns
Scuffed (Unpainted)
Over 100mm

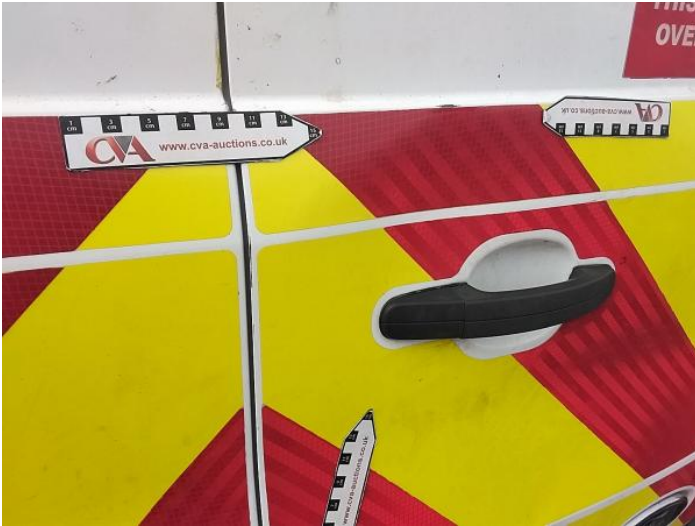
39: Door osr
Dented
Over 30mm

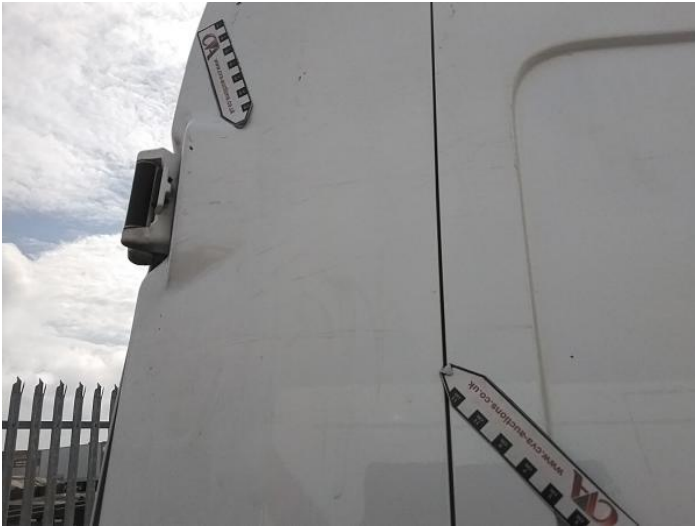
45: C Post os
Scratched
Over 25mm Thru Paint

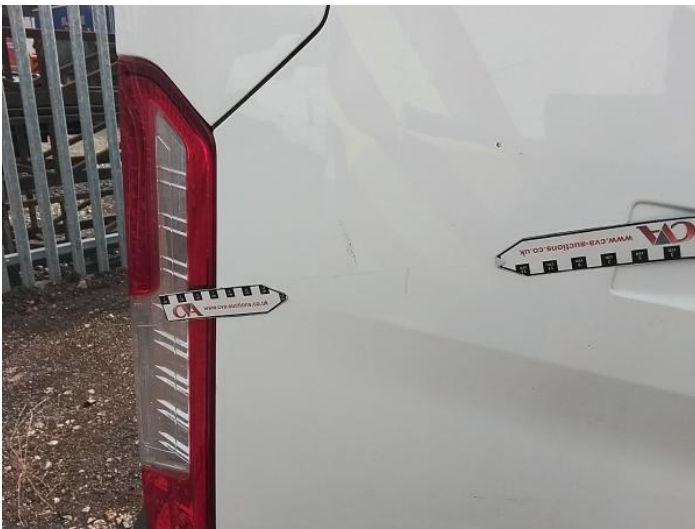
47: Qtr Panel osr
Scratched
Over 25mm Thru Paint

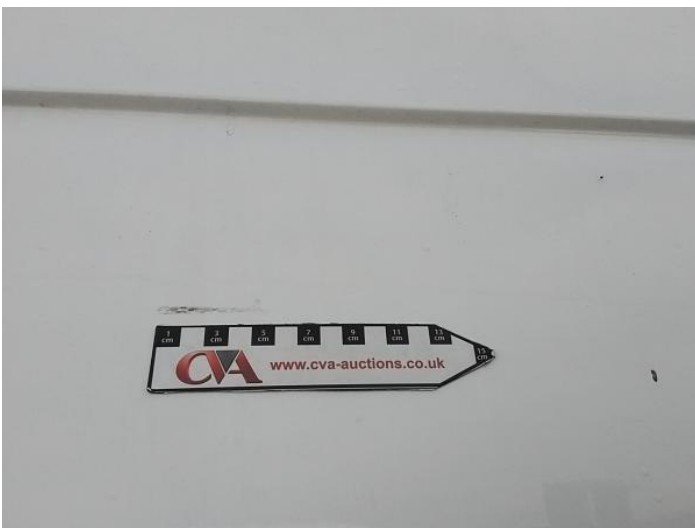
49: Qtr Panel osr
Scratched
Over 25mm Not Thru Paint

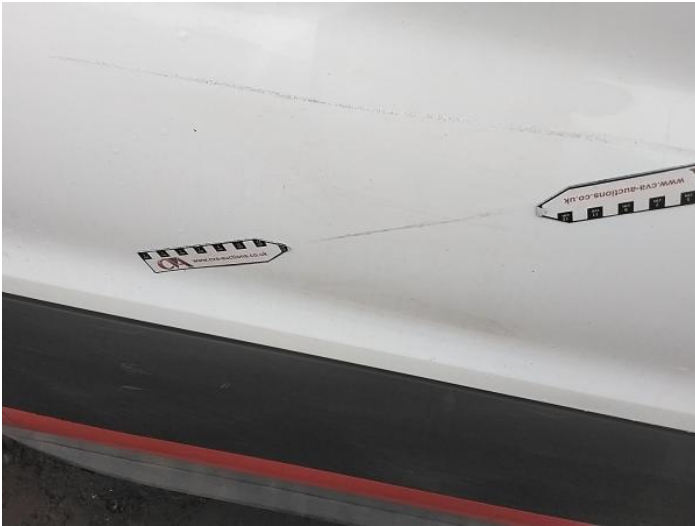
51: Qtr Panel osr
Scratched
Over 25mm Not Thru Paint

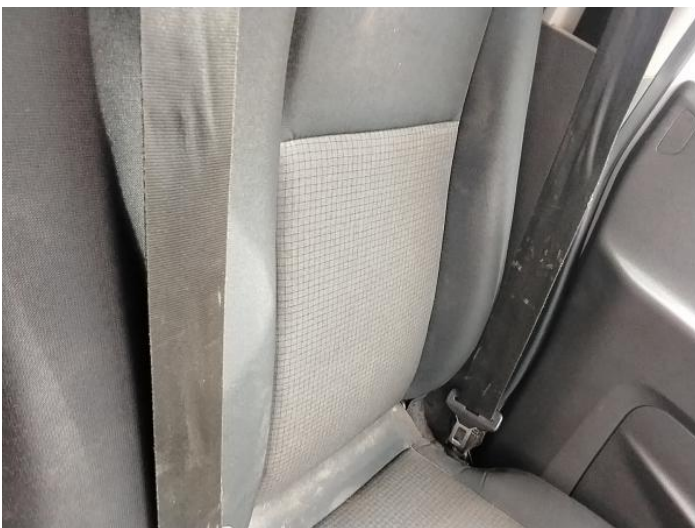
60: Seat Base Cover nsf
Soiled
Heavy

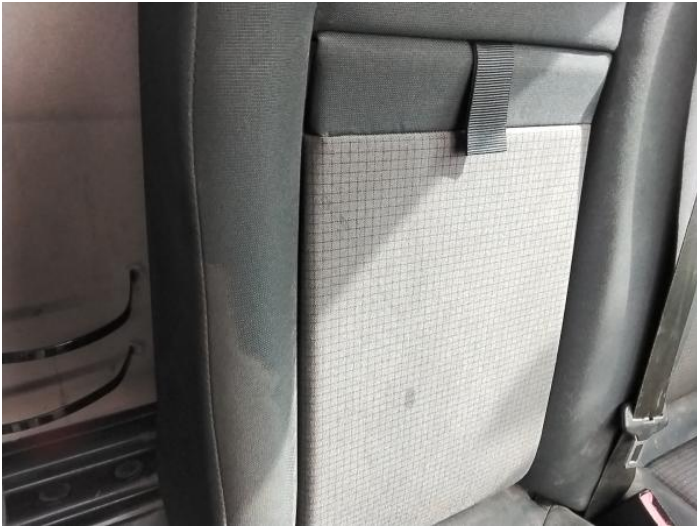
62: Seat Base Cover nsf
Soiled
Heavy

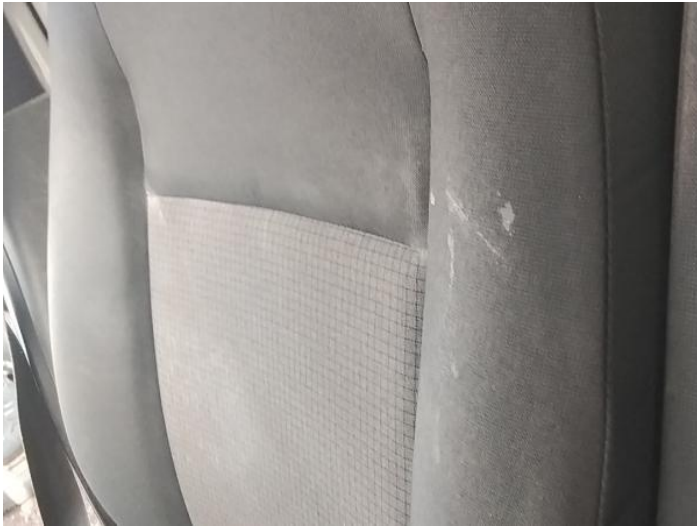
63: Seat Back Cover nsf
Soiled
Heavy

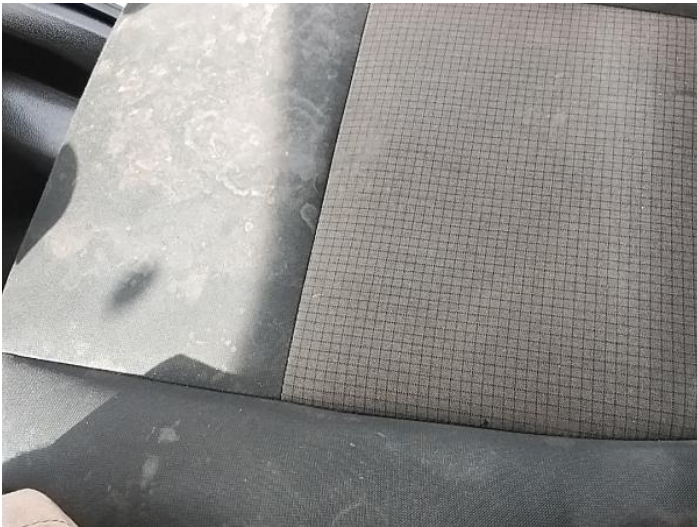
64: Seat Back Cover osf
Soiled
Heavy
