# VEHICLE INSPECTION REPORT

**CU64FKG**

## Ford Transit 350 2.2 TDCI 100PS

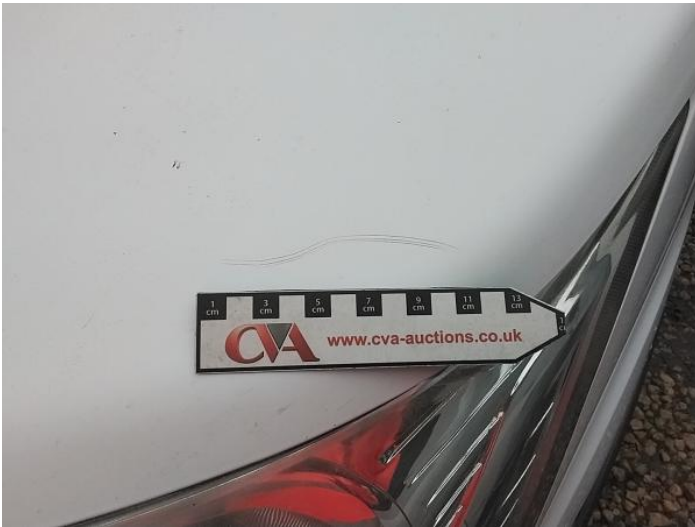
5: Bonnet  
Scratched  
Over 25mm Thru Paint

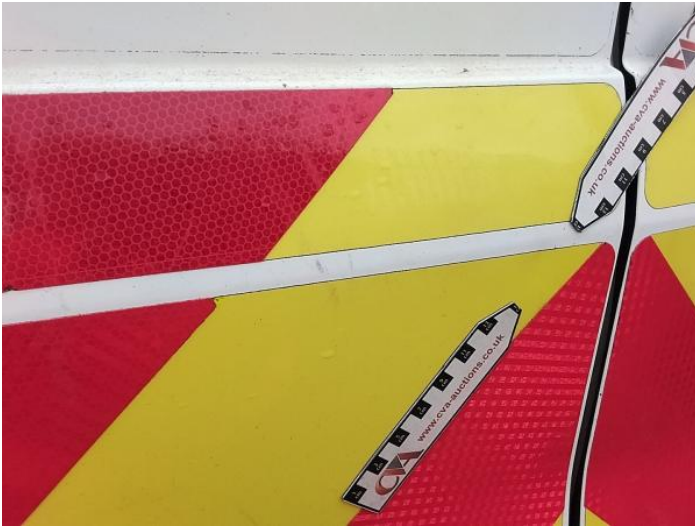
33: Door nsr  
Dented  
Over 30mm
